FILE 5023047
MAYNARD TOPAZ
MINE

Surface Examination Report
Field Files ML-34698
ML-33388
ML-33042
July 25, 1995

Date of Inspection: July 17, 1995

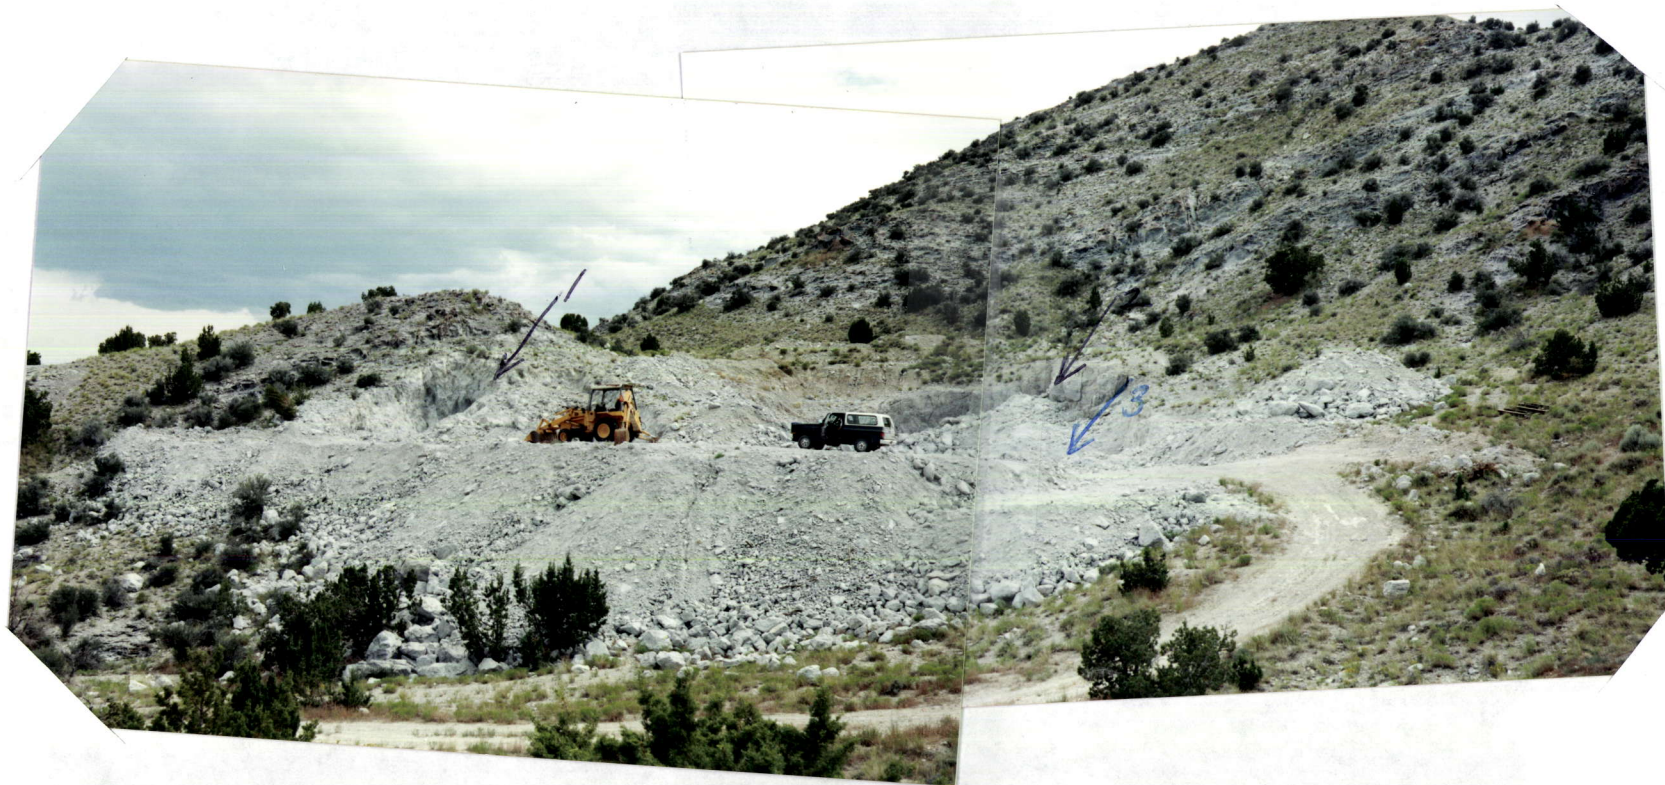
The only mine related surface disturbance is located in the SW $\frac{1}{4}$ NW $\frac{1}{4}$ SE $\frac{1}{4}$ as shown in the accompanying map. This disturbance may slightly overlap onto lands in the SW $\frac{1}{4}$ SE $\frac{1}{4}$. The disturbance comprises two main areas of mining activity as shown in the photographs accompanying this report. It was difficult to determine if there has been any actual mining on the leased lands in calendar year 1995 as the Backhoe which is parked at the mine site does not appear to have been moved in several months. No trespassing signs posted on the leased lands have been dated as of 3/?/1995. Mine area # 1 as shown in photo # 1 is approximately 75 feet X 75 feet, a total disturbed area of approximately 5,525 sq. feet or .13 acres. Mine area # 1 is identified in the Lessee's NOI as the current active mining area. Mine area # 2 as shown in photo

1 is approximately 250 feet X 105 feet, a total disturbed area of approximately 26,250 sq. feet or .6 acres. Mine area # 2 is identified as a previously disturbed mine area which was to be reclaimed by the end of 1995. Mine area # 2 does appear to be the site of some back-filling but at the time of this inspection mine area # 2 cannot be considered reclaimed. Photograph # 2 depicts a deep excavation within Mine area #2 which is identified in the Lessee's NOI as an area that will be back-filled and reclaimed in 1995. The total approximate area of mine disturbance is 31,875 sq. ft., which is approximately .73 acres, with .6 acres scheduled to be reclaimed in calendar year 1995. The area of disturbance was approximated by pacing the width and length of each area of disturbance at several locations and averaging the widths and lengths to obtain an average area of disturbance. The access road to the mine site does not appear on the topographic map and must be considered part of the disturbance created by the mining activity. At a minimum the access road, as it crosses State Trust land only, is approximately 2,700 feet and 10 feet wide. The total disturbance created by the access road as it crosses only Trust land is .62 acres. The total disturbance on Trust land, which is not included for reclamation in 1995, is .75 acres, this includes mine site # 1 and the access road to the mine. Of some concern are the high walls and pits created by mining activity as shown in Photo # 2. As a result of this surface inspection the Lessee will be required to post additional reclamation bonding and will be required to reduce the slope of the high walls.

Photo # 1, Looking south onto mine disturbance on ML-33388 & ML-33042. Arrow # 1 shows the location of active mining. Arrow # 2 shows the location of an old excavation which is to be reclaimed by the Lessee in 1995. Arrow # 3 shows the location of the excavation as shown in Photo # 2.

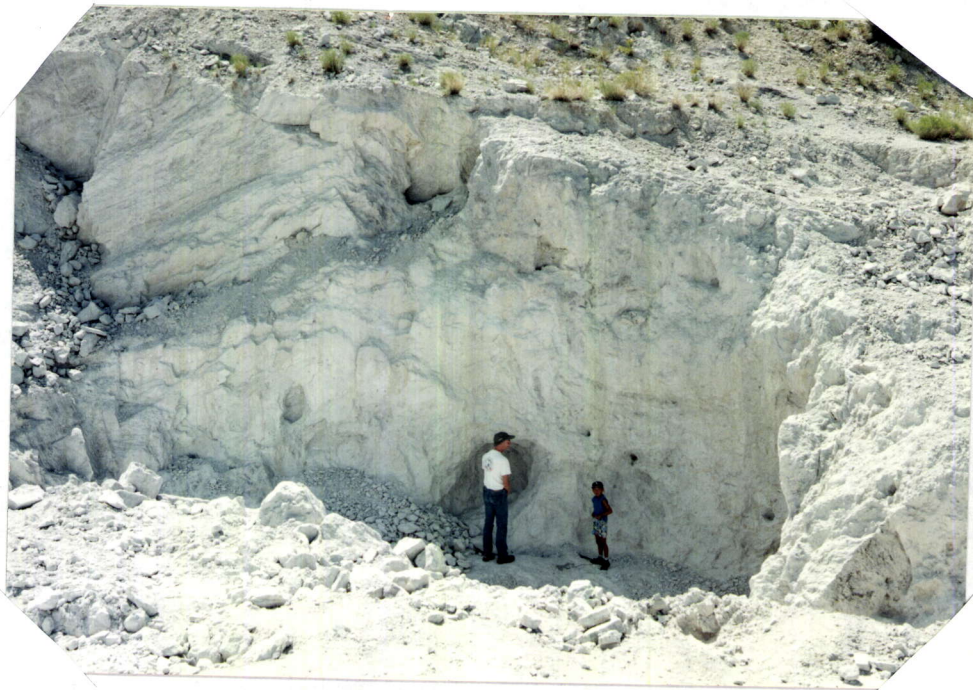
Photo # 2, looking into excavation, the location of which is depicted by arrow # 3 in Photo # 1.
This excavation is to be reclaimed by the end of the 1995 calendar year.
